A Report on Mw 6.7 Manipur Earthquake of January 4, 2016

B. K. Rastogi

Institute of Seismological Research, Raisan, Gandhinagar-382 009

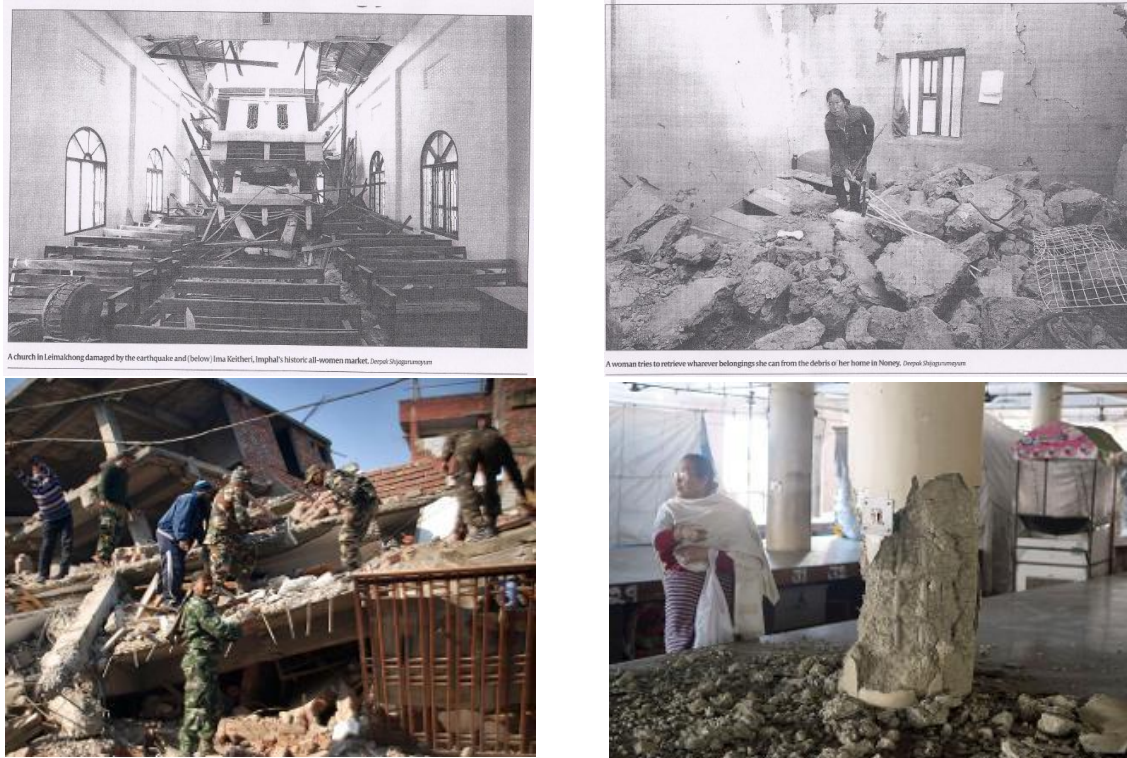
At Imphal, Hotel Nirmala tilted and sunk probably due to liquefaction. Minithong bridge cracked. Buildings in main market cracked. Partial collapses in all women market, named Ima Keithal, Ima, meaning mother and Keithal meaning market. Many pillars failed and walls collapsed. Church collapsed in Ukhrul. Total 165 houses collapsed (Fig. 5).

Fig. 5a: Clockwise from top (a) Damaged Imphal church (b) Collapsed house in Imphal (c) Collapsed new buildings in Imphal market (d) Collapsed walls and failed pillars in All Women Market

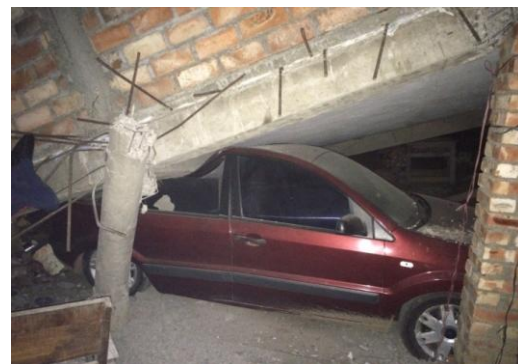
Fig. 5c: Building Collapse, Imphal

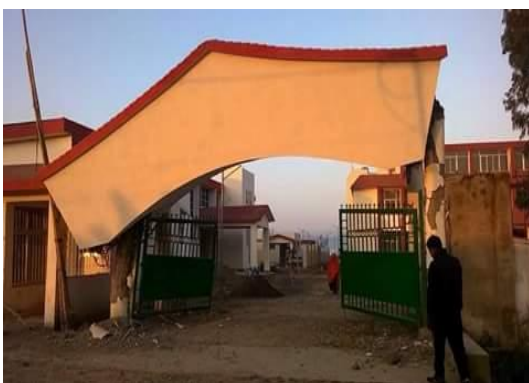
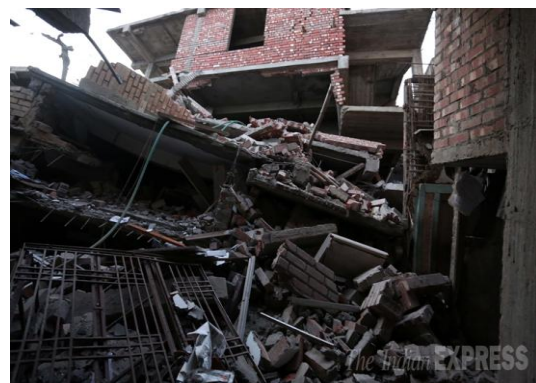
Fig. 5d: Damaged buildings in Imphal.

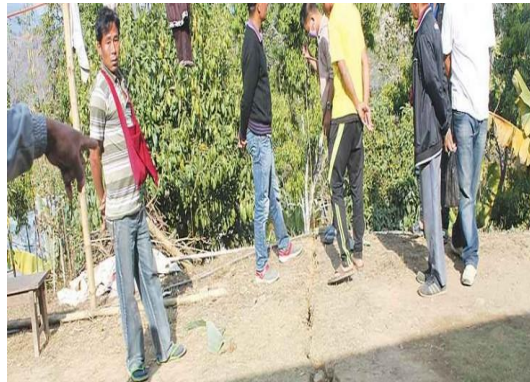
Large cracks developed during the quake at Noney (Longmai) Part-1. It ejected vapour-smoke on 7th January, 2016 morning. On the other hand, quantity of water flowing down from the hill streams has increased after the tremor. Several houses developed cracks in Silchar (80km) and Dimapur (100 km) where MMI is assigned VI.

Fig. 5f: Cracks developed at Noney

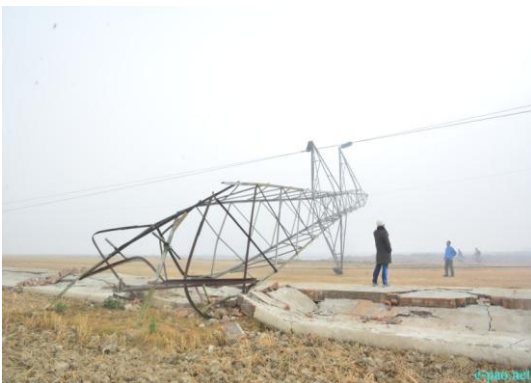
Fig. 5g: Damaged road and power line, Imphal

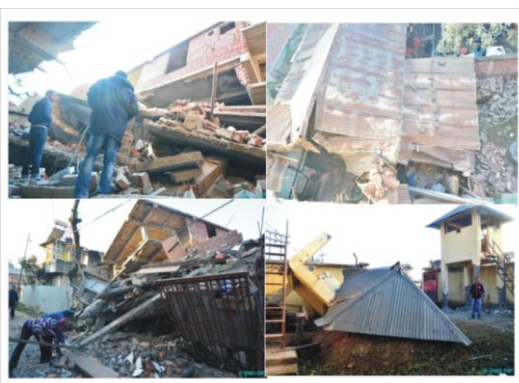
Fig. 1h: Damages in Dewlahand, Wangkhei Angom leikai, Tabungkhok and Lamshang localities of Imphal
